Manhole Inspection Summary

Manhole # S13EE1003MH

Location Address: **2800 OSWEGO AVE**

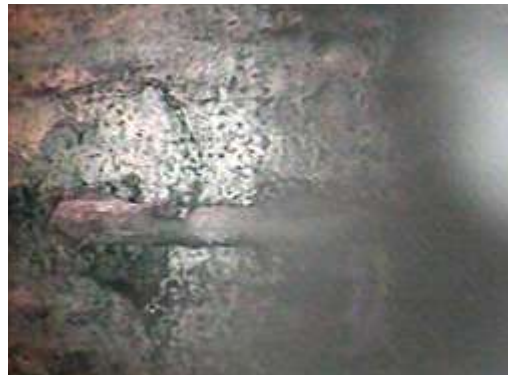
Defect 1

Count: **9** Missing: **0** ☒ **Corroded**

☒ **Evidence Of Surcharge** Depth: **6** (ft.) ☐ Active Surcharge Present

EVIDENCE OF SURCHARGE /
CORROSION

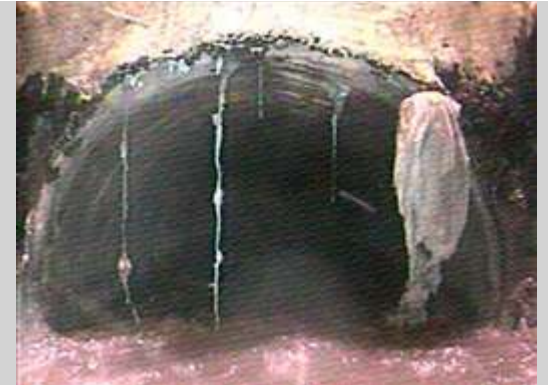
12 O'Clock Outflow

21 in. Circular Gravity Sewer
Pipe Out @ 12 O'Clock

Infiltration: **None** Pipe Seal Cond: **Sound**

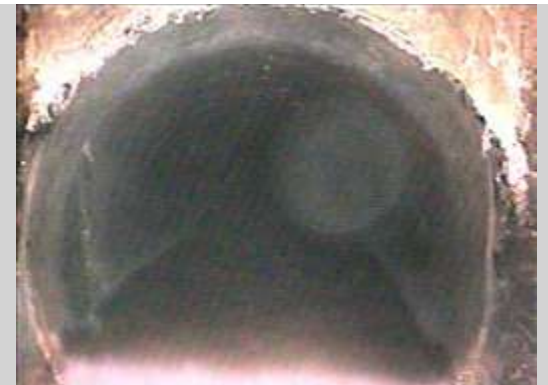
6 O'Clock Inflow

21 in. Circular Gravity Sewer
Pipe In @ 6 O'Clock

Infiltration: **None** Pipe Seal Cond: **Sound**

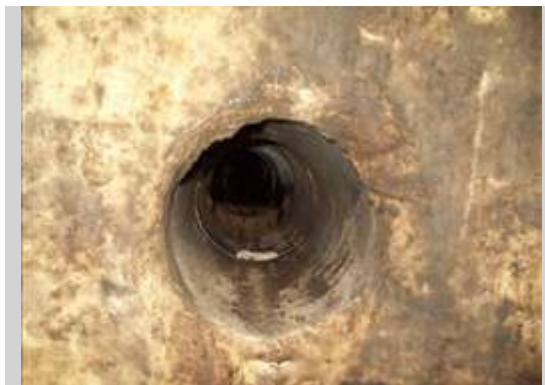
9 O'Clock Inflow

8 in. Circular Gravity Sewer

Pipe In @ 9 O'Clock

Infiltration: **None** Pipe Seal Cond: **Sound**

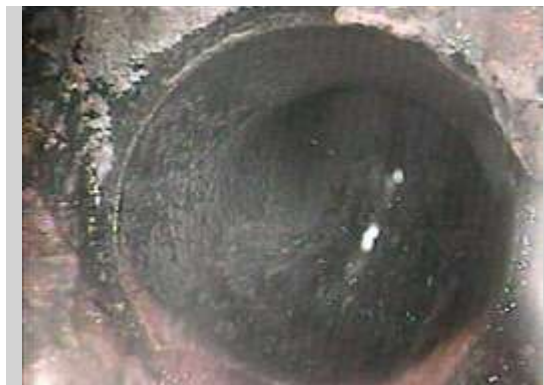
Drop In @ 9 O'Clock

Drop: **Inside** **Direct**

Inv Depth: **10.40** (ft.)

Drop Condition: **Open**
